Contract #: 04-0120F4Cty: SF/ALA Rte: 80 PM: 13.2/13.9File #: 69.28**WELDING INSPECTION REPORT****Resident Engineer:**Pursell, Gary**Address:** 333 Burma Road**City:** Oakland, CA 94607**Report No:** WIR-015214**Date Inspected:** 26-Jun-2010**Project Name:** SAS Superstructure**OSM Arrival Time:** 700**Prime Contractor:** American Bridge/Fluor Enterprises, a JV**OSM Departure Time:** 1900**Contractor:** Zhenhua Port Machinery Company, Ltd (ZPMC), Changxing Island **Location:** Shanghai, China**CWI Name:** Le Zhi Jiang**CWI Present:** Yes No**Inspected CWI report:** Yes No N/A**Rod Oven in Use:** Yes No N/A**Electrode to specification:** Yes No N/A**Weld Procedures Followed:** Yes No N/A**Qualified Welders:** Yes No N/A**Verified Joint Fit-up:** Yes No N/A**Approved Drawings:** Yes No N/A**Approved WPS:** Yes No N/A**Delayed / Cancelled:** Yes No N/A**Bridge No:** 34-0006**Component:** Orthotropic Box Girder (OBG)**Summary of Items Observed:**

OBG # CROSSBEAM CB13

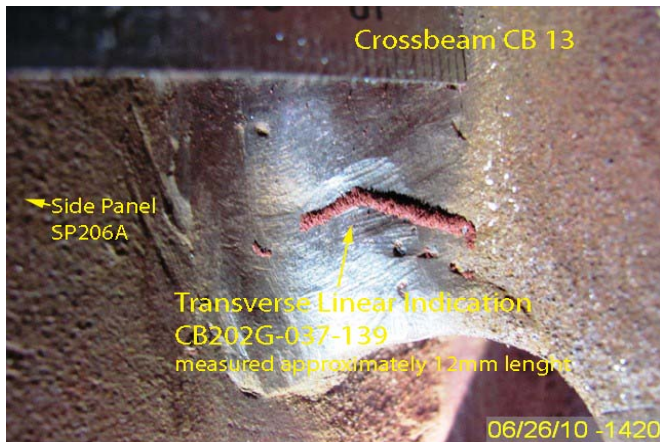
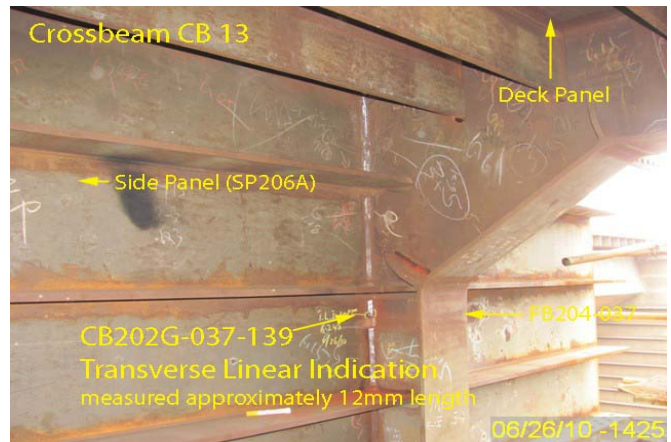
(CB202G-037-139) Non compliant indication

During the Quality Assurance Magnetic Particle Testing (MT) review of welds located on Orthotropic Box Girder (OBG) Cross Beam CB13, this Quality Assurance Inspector (QA) discovered the following issues. One Transverse crack indication measuring approximately 12mm in length. The crack indication is located in weld identified as CB202G-037-139. The weld is a fillet weld joining the side panel (SP206A) stiffener to the floor beam identified as FB204-037. Y location of this indication is 980mm from the deck panel. The indication is clearly marked on the material. This QA notified ZPMC QA identified as Mr. Zhang wei of this issue and that an incident report would be generated. For more information refer Magnetic particle Test report for this date. See attached picture
